MISCELLANEOUS PAPER N-71-3

DYNAMIC TESTS OF A MODEL FLEXIBLE-ARCH-TYPE PROTECTIVE SHELTER

April 1971

Conducted by U. S. Army Engineer Waterways Experiment Station, Vicksburg, Mississippi

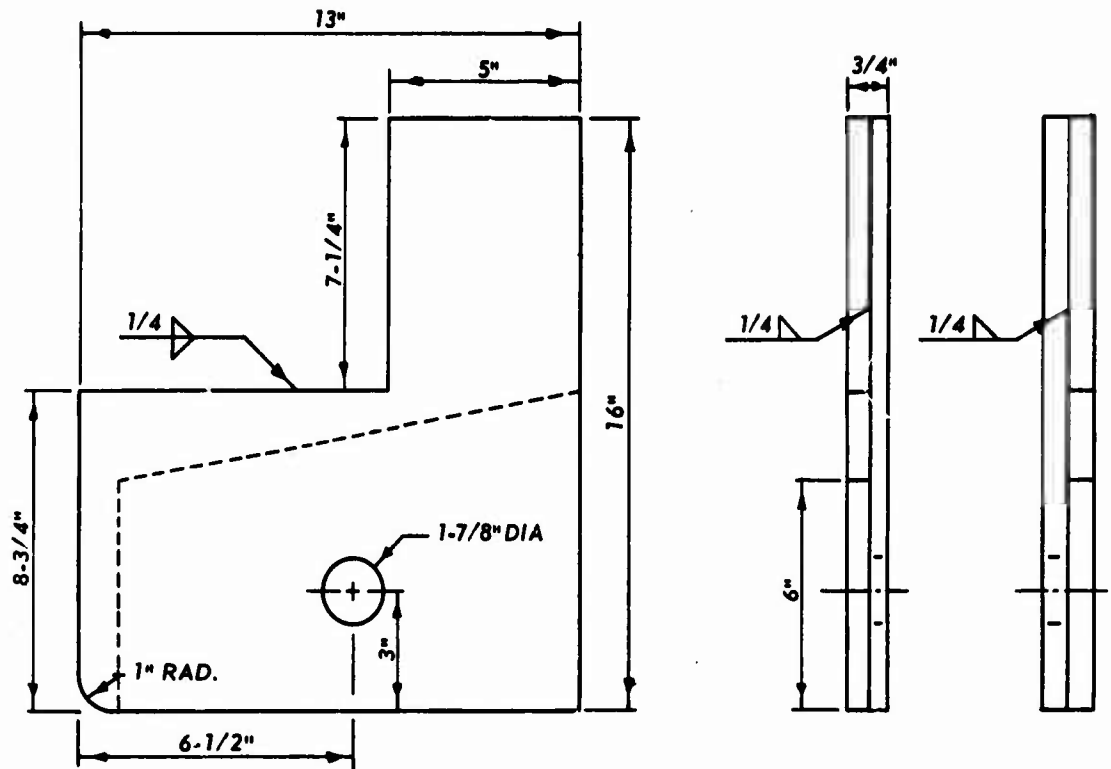
Prototype truss design calls for 8.2-lb/ft, 6-inch channel to be used as
this connector. This means that a reinforcing strip on either side can
only be 4.5 inches wide and, thus, the thickness of this plate should be
7/16 inch. This yields an area of 3.2 in^2. These plates are to extend
5 inches past the outer edge of the truss as shown in Figure D.3. Column
modifications are made as shown in Figures D.4 and D.5. Using the 3/8-
inch plate as shown and assuming that the resisting area extends above
the pin a distance equal to the length below, then the resisting area is

Figure D.3 Detail of the modifications made in the prototype truss connector design.

Based on the laboratory findings, it is recommended that the bulkhead truss connection be redesigned as outlined in Appendix D. This redesign will eliminate problems occurring as a result of truss rotation. With regard to the truss itself, it is recommended that a cheaper configuration be designed. It is possible to use a pair of the arch ribs laid flat and connected to the bulkhead column bases by rods.
